WRDC-TR-89-4055

COMPENDIUM OF FRACTOGRAPHIC DATA FOR COMPOSITE
MATERIALS

INTERIM REPORT
Covering 9-22-86 through 10-31-88

C. Hua
M. Yamashita
Boeing Advanced Systems
P.O. Box 3707
Seattle, WA 98124

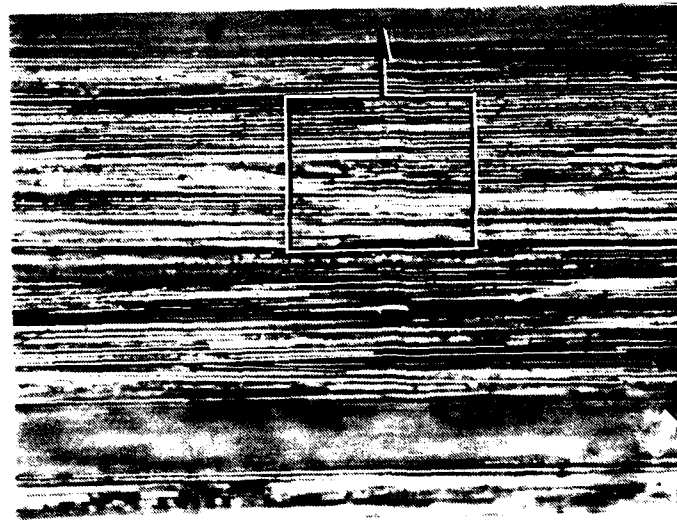
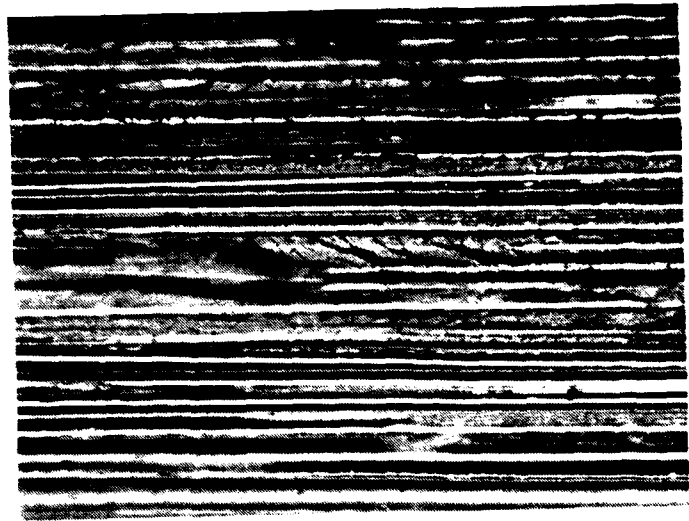
Figure 4.4-80. Optical Photomicrographs of Interlaminar Mode I Tension, 0/0 Fracture of a Filament Wound Specimen

In optical photomicrographs fracture features were very difficult to identify due to the low resin content. However, at high magnification, fine rivermarks were observed (Fig. 4.4-80).

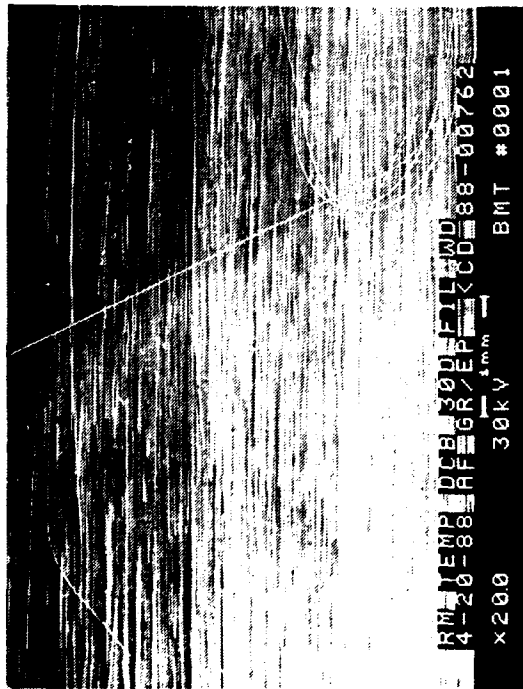
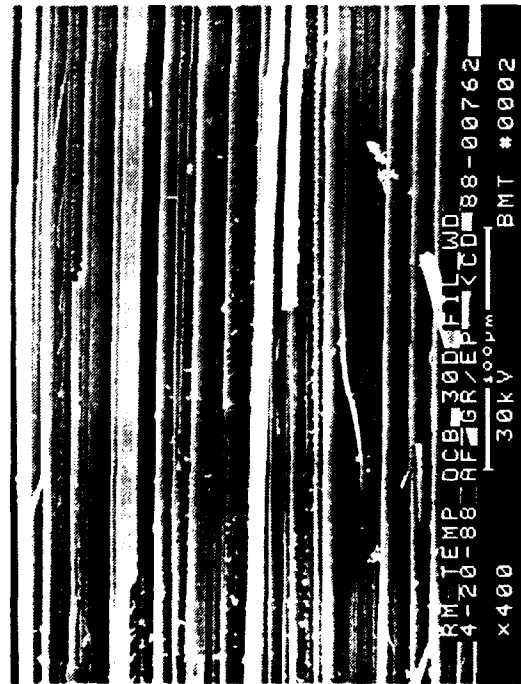
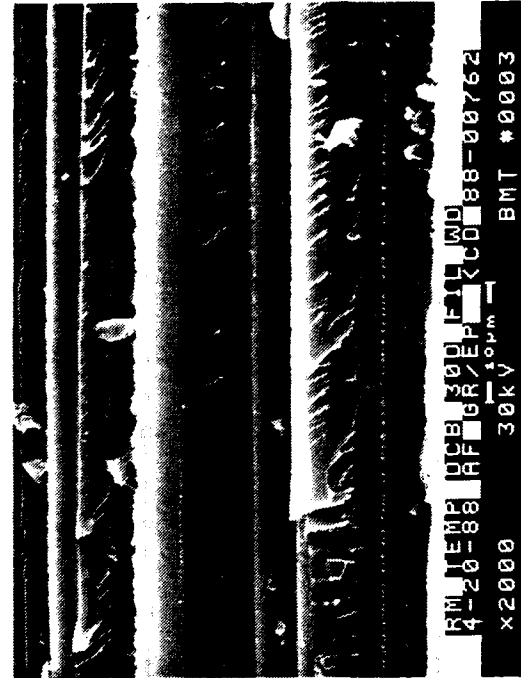
Figure 4.4-81. SEM Fractographs of Interlaminar Mode I, 0/0 Fracture of Filament Wound Specimen

These fine rivermarks were also observed under SEM. Due to the lack of resin surrounding the fibers, the fiber/matrix adhesion was rather poor as evidenced by the stray fibers on the fracture surface (Fig. 4.4-81).

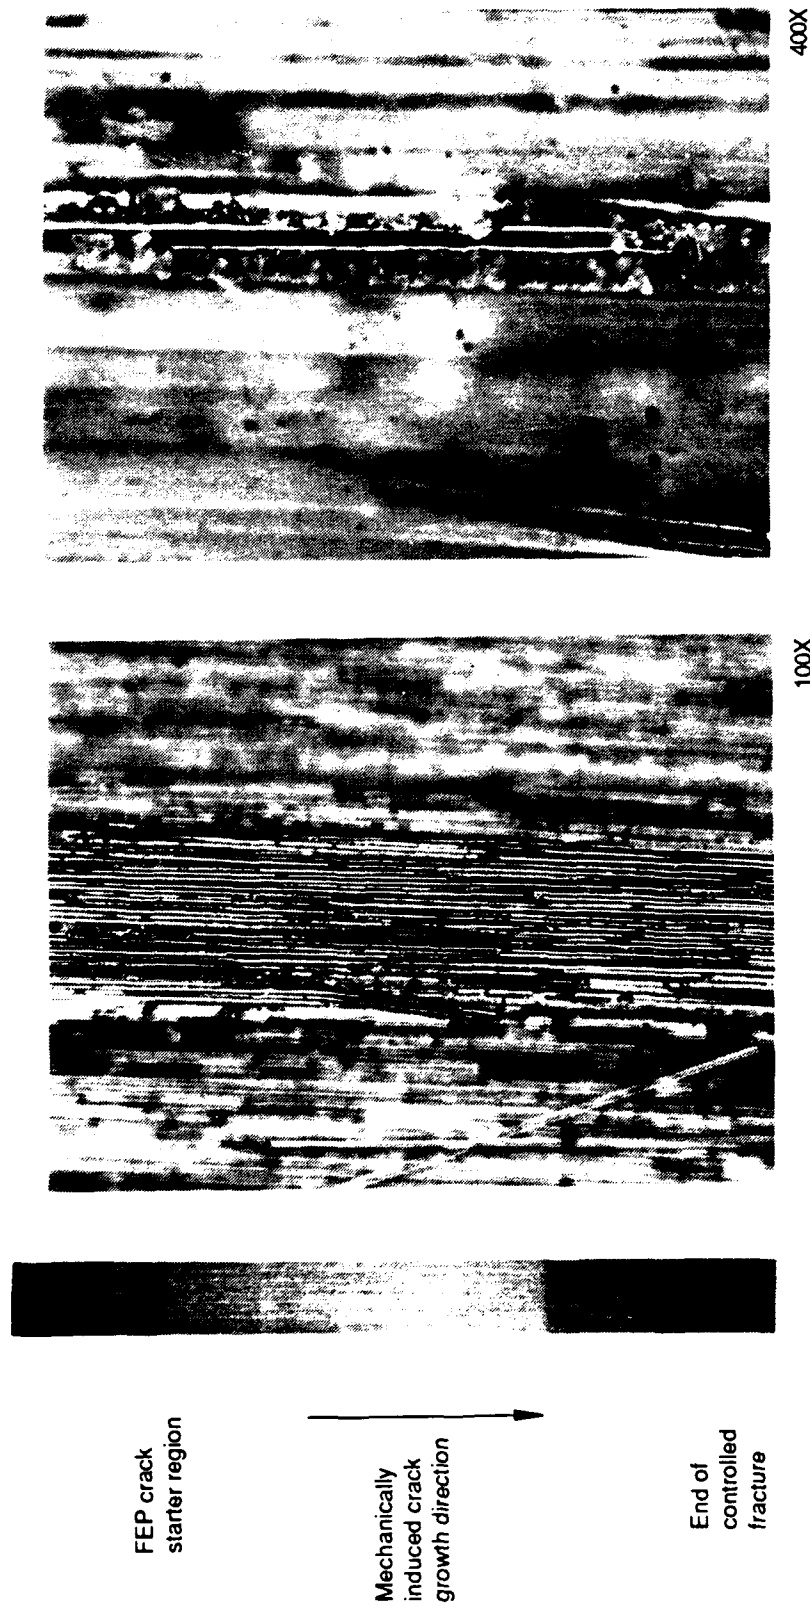
Figure 4.4-82. Optical Photomicrographs of Interlaminar Modell, 0/0 Fracture of Filament Wound Specimen

Under optical microscopy, hackles were observed only at locations where there was a sufficient amount of resin between the fibers (Fig. 4.4-82). The hackles observed under the SEM were very small due to the low resin content. The fiber/matrix adhesion seemed to be poor at resin-starved regions as evidenced by bare fibers (Fig. 4.4-83).

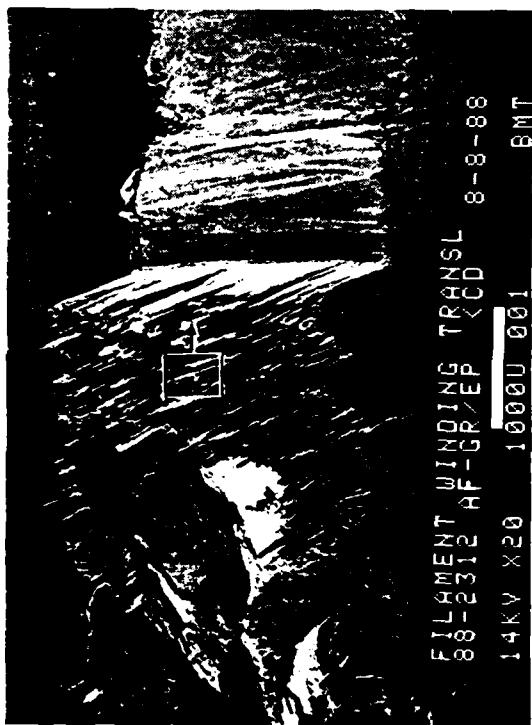
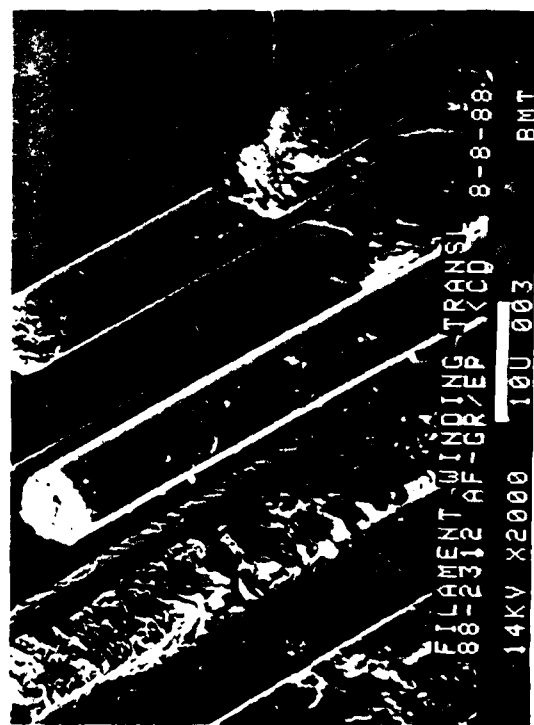
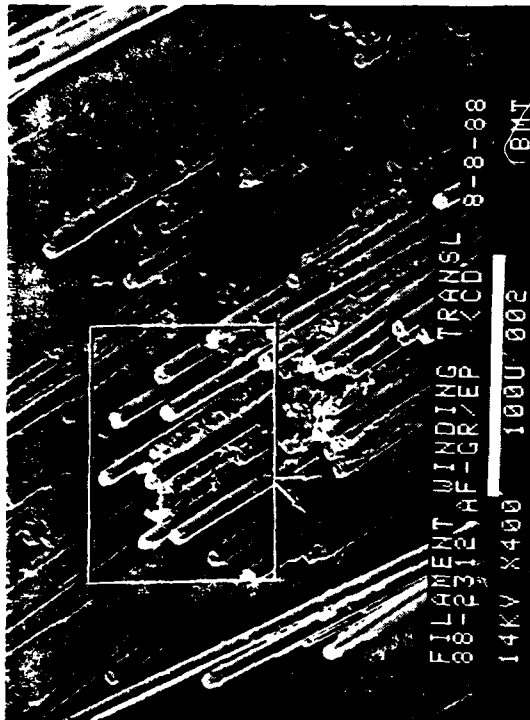
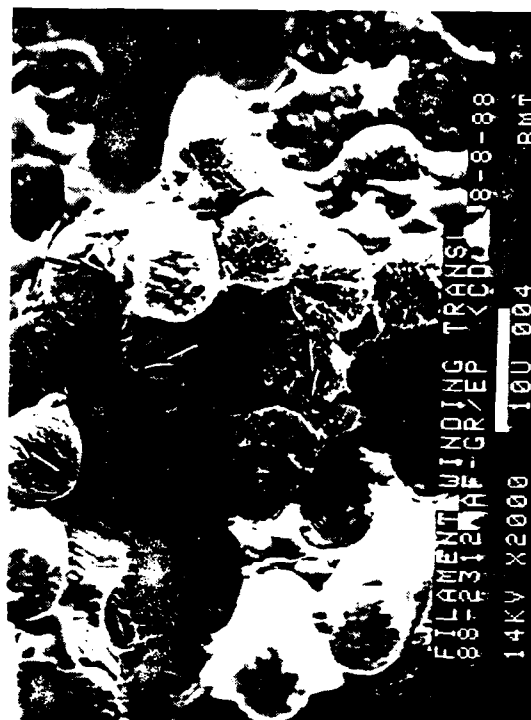
Figure 4.4-84. SEM Fractographs of Translaminar Tension Fracture of Filament Wound Specimen

Translaminar Tension. The fiber/matrix adhesion was good and radial patterns commonly observed in carbon fibers were present on the fiber ends. From these patterns, it was possible to obtain the overall crack propagation direction (Fig. 4.4-84).

(a) Overall view 20X

(c) Good fiber/matrix adhesion 2,000X

(b) Protruding fibers 400X

(d) Radial patterns on fiber ends 2,000X

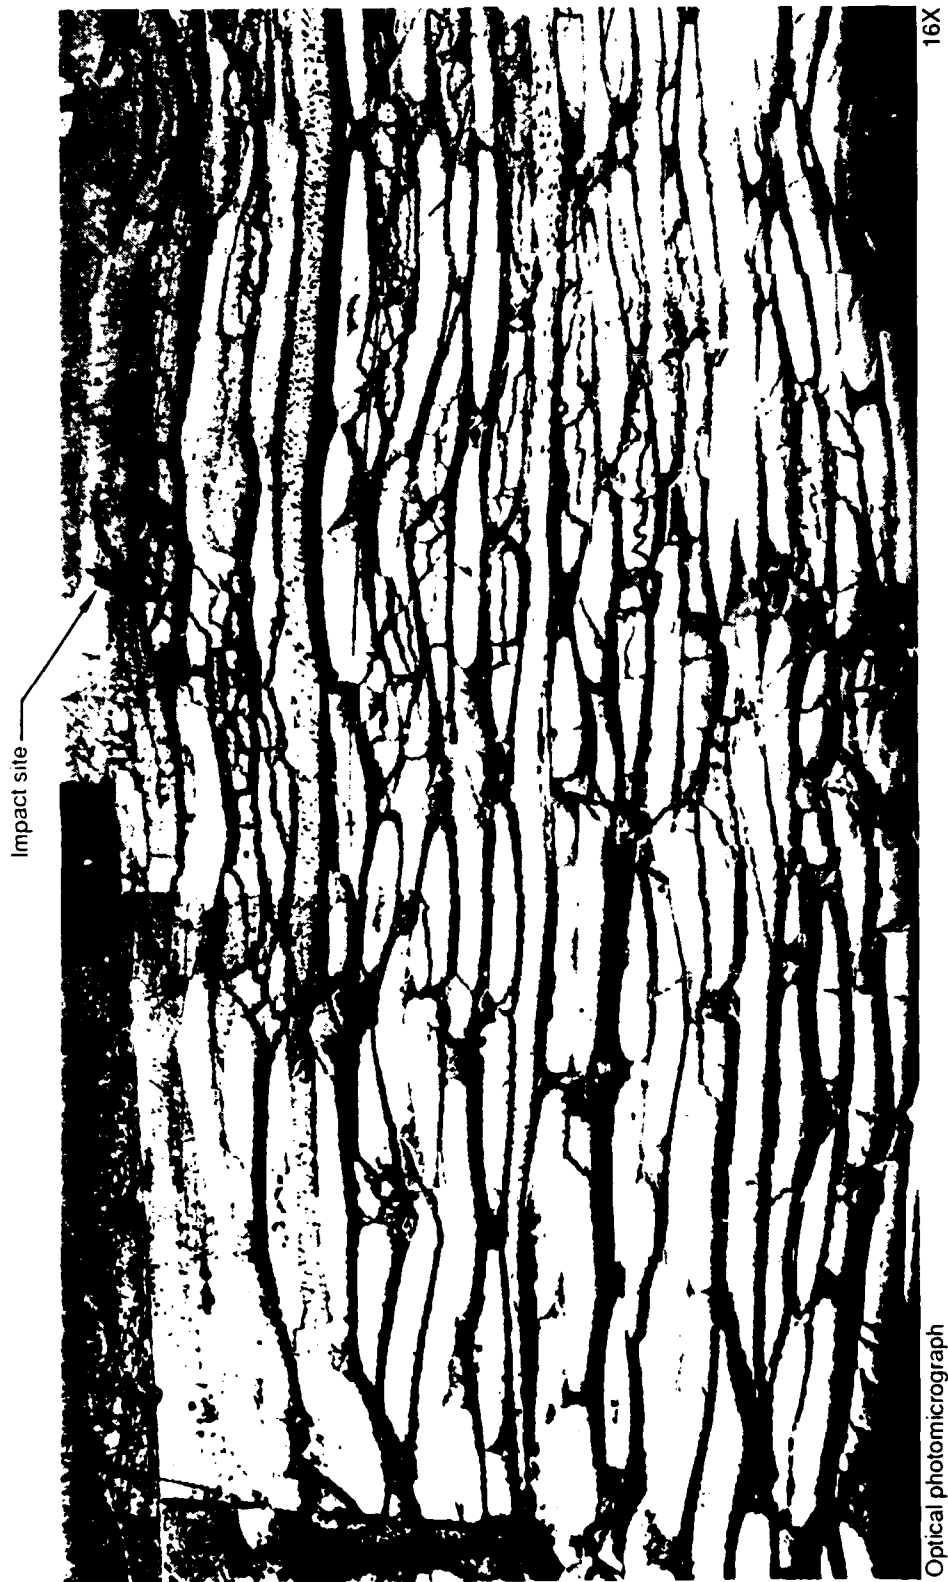
Figure 4.4-85. Cross-Sectional View of Compression-After-Impact Fracture of AS-4/3501-6 Stitched with Kevlar 29

Stitch (CAI). An AS4/35601-6 specimen was stitched with Kevlar 29. Fractographs of the specimen tested under CAI were documented. The ply-by-ply crack propagation showed an irregularly arranged, complex pattern (Fig. 4.4-85). The damage around the Kevlar 29 stitch was composed of interlaminar and translaminar cracks (Fig. 4.4-86).

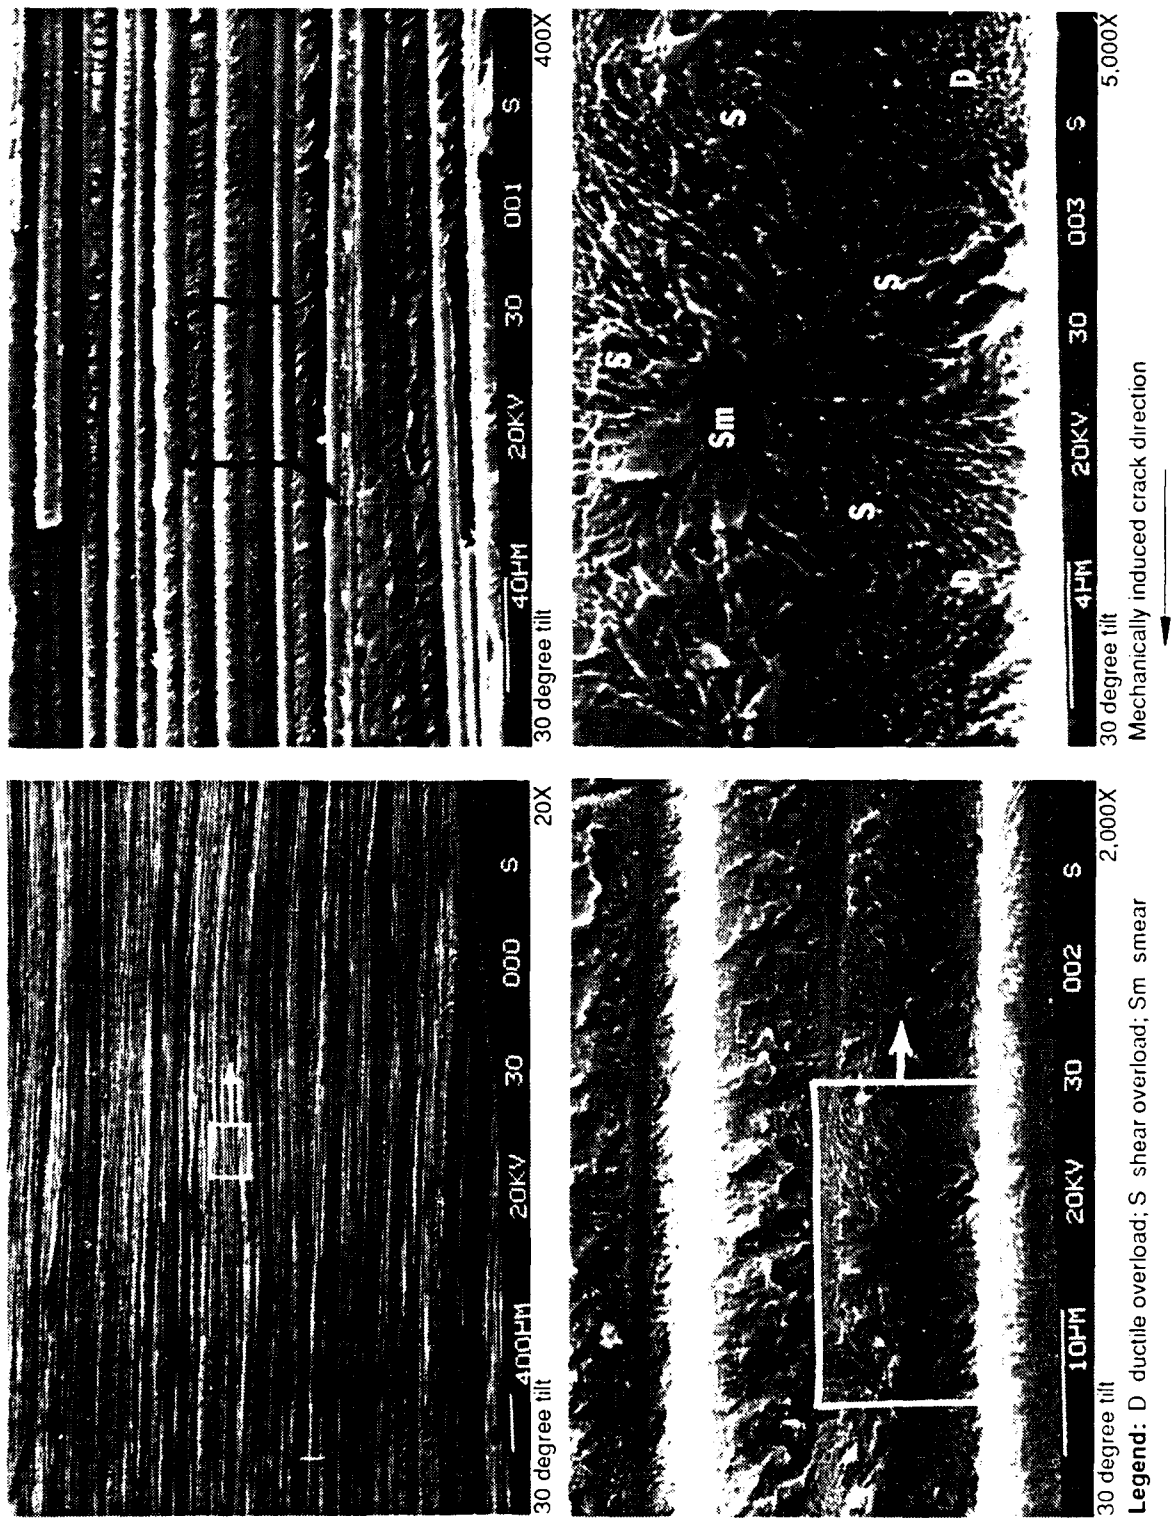
Figure 4.4-87. SEM Fractographs of Room Temperature, Interlaminar Mode I Fracture in AS-4/APC-2

Interlaminar Mode I Tension, RT/Dry. Optical examination revealed a dull, matte interlaminar surface, unlike the reflective Mode I fractures observed in carbon/epoxy. SEM examination revealed features similar to ductile overload dimples observed in metals (Fig. 4.4-87). These were found in radial patterns due to the influence of semi-crystalline formations, termed spherulites, within the PEEK matrix. The fractographs are indicative of a fast, brittle fracture. A slow fracture is characterized by high ductility. No overall crack propagation direction could be determined. Fiber/matrix adhesion was good.

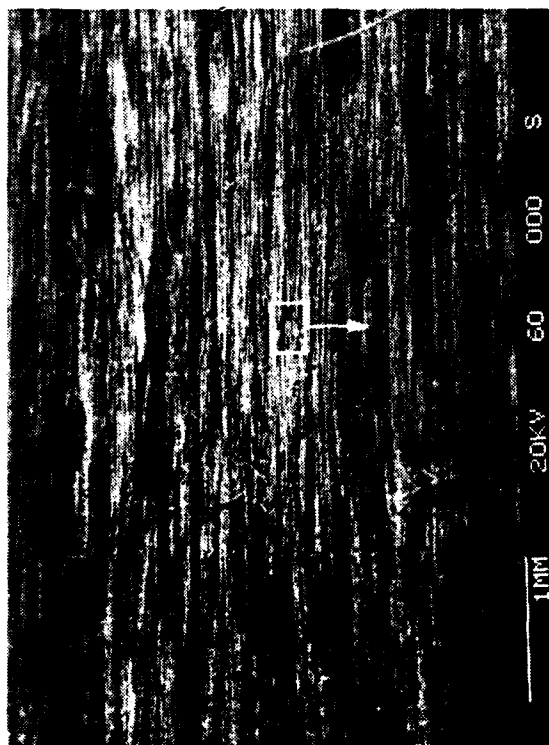
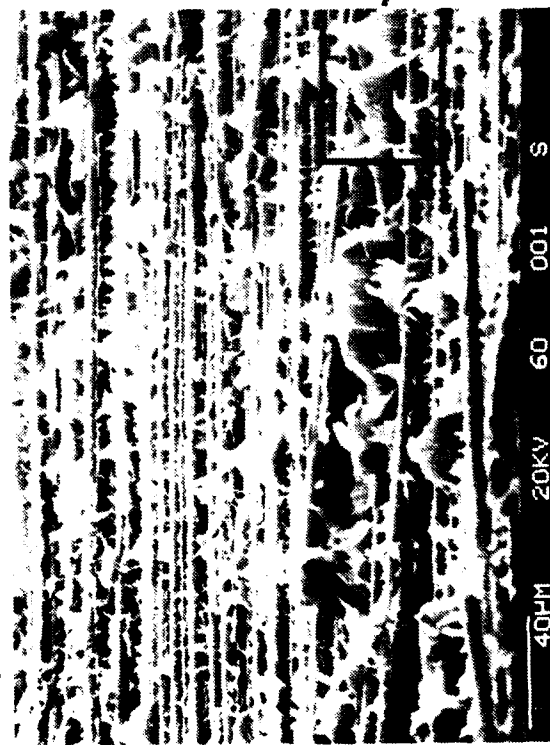
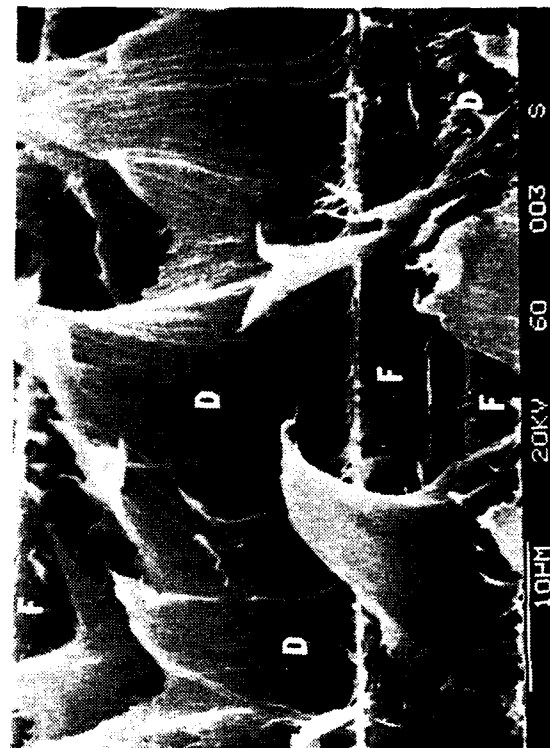
Figure 4.4-88. SEM Fractographs of 270 F/Wet, Interlaminar Mode I Tension Fracture in AS-4/APC-2

Interlaminar Mode I Tension, 270°F/Wet. Optical examination revealed a white fracture surface due to the presence of ductile tufts of material. SEM examination revealed ductile matrix fracture, showing the small tufts of matrix which were drawn perpendicularly to the fracture plane (Fig. 4.4-88). This morphology is typical of a slow, ductile fracture in PEEK matrix. Overall crack propagation direction could not be determined. Fiber/matrix adhesion was good.

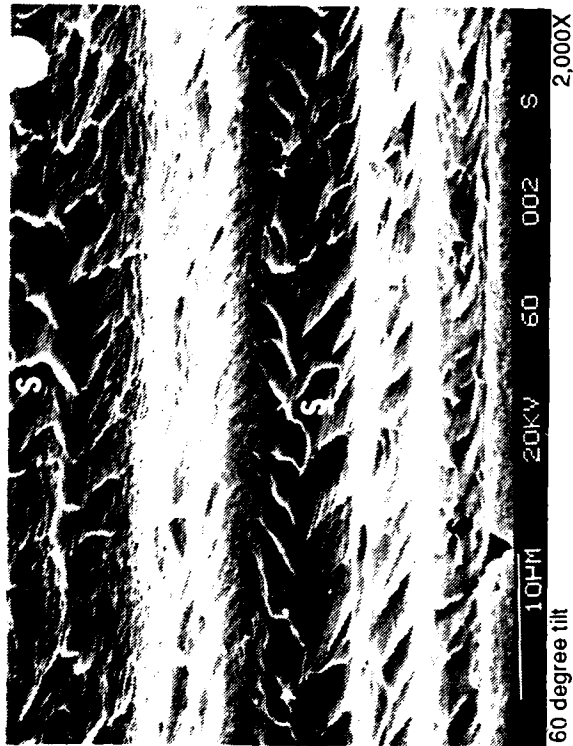
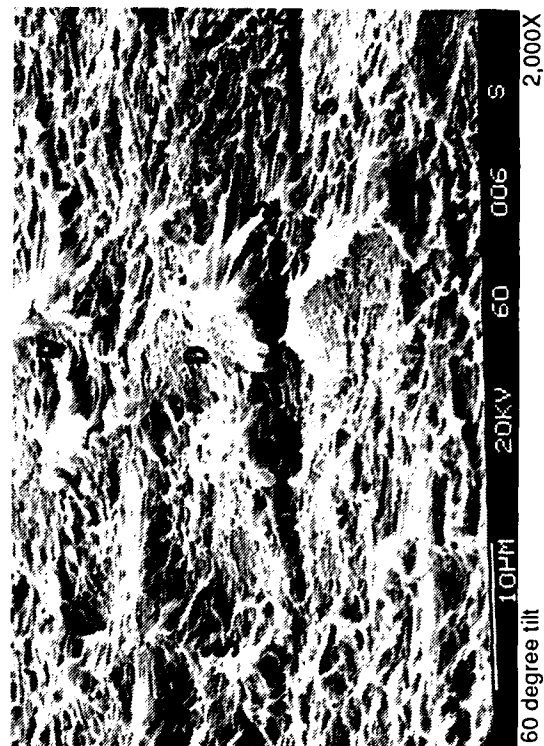
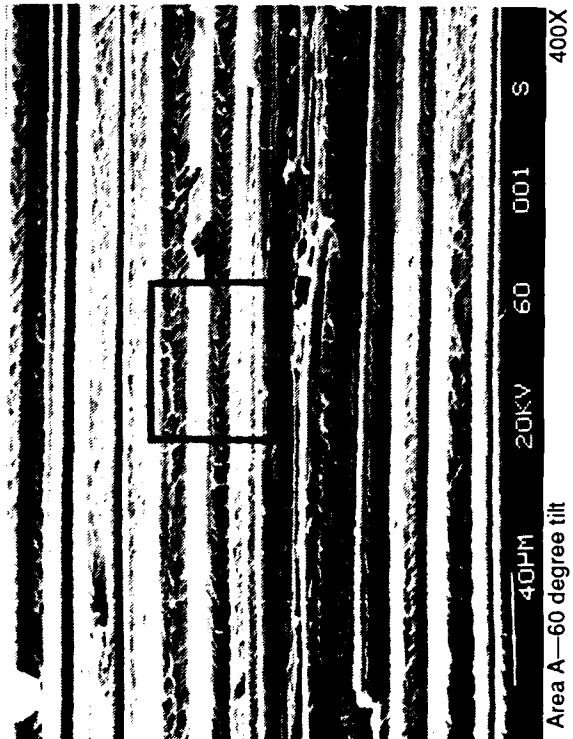
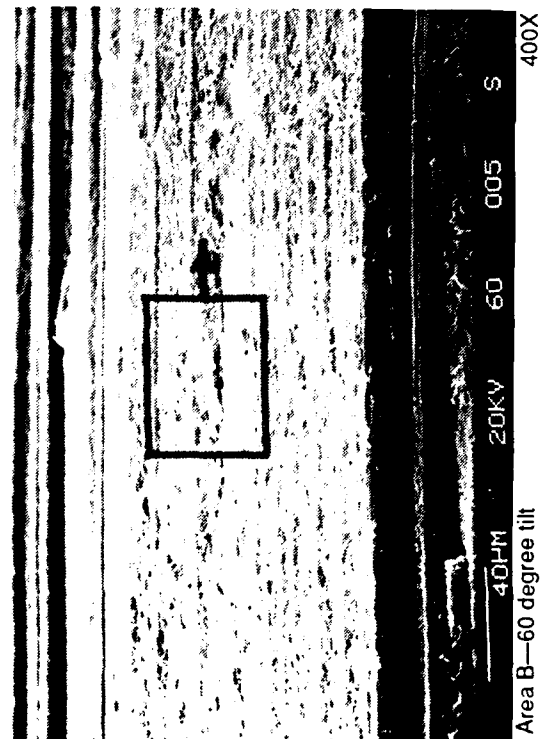
Figure 4.4-89. SEM Fractographs of Room Temperature, Interlaminar Mode II Fracture in AS-4/APC-2

Interlaminar Mode II Shear, RT/Dry. Optical examination revealed a distinct transition point from the Mode I precrack to Mode II shear propagation. SEM examination revealed ductile shear dimples similar to those observed in metals (Fig. 4.4-89). Unlike hackles, these features make it possible to determine the relative shear directions of the mating fractures. Resin-rich areas between plies revealed mixed features of ductile overload and ductile shear. Fiber/matrix adhesion was good.

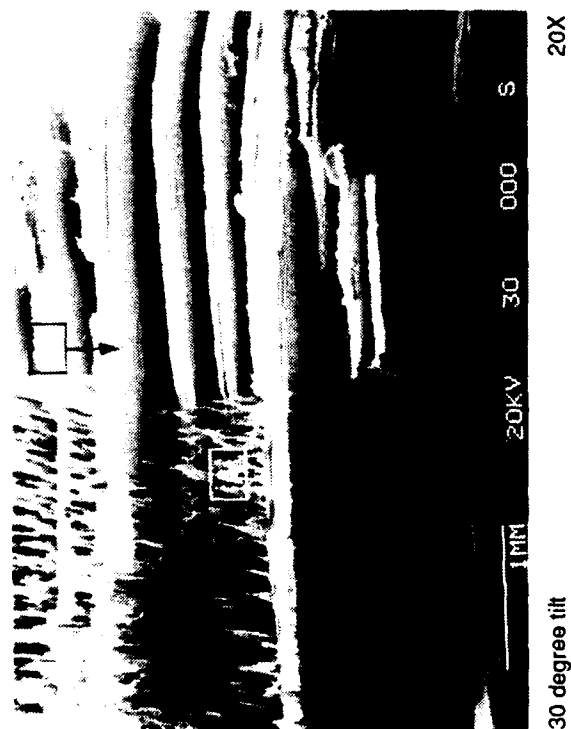
Figure 4.4-94. SEM Fractographs of 270 F/Wet, Translaminar Compression Fracture in AS-4/APC-2

Translaminar Compression, 270°F/Wet. Optical examination revealed approximately 50% compressive and 50% tensile fracture. SEM examination of the compressive zone revealed fiber end fractures having tensile, compressive, and neutral zones typical of compressive fractures (Fig. 4.4-94). Fiber/matrix adhesion was good.

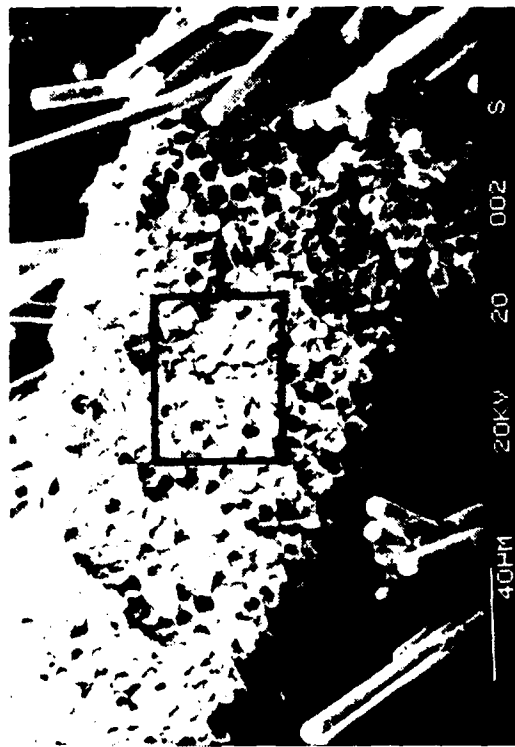
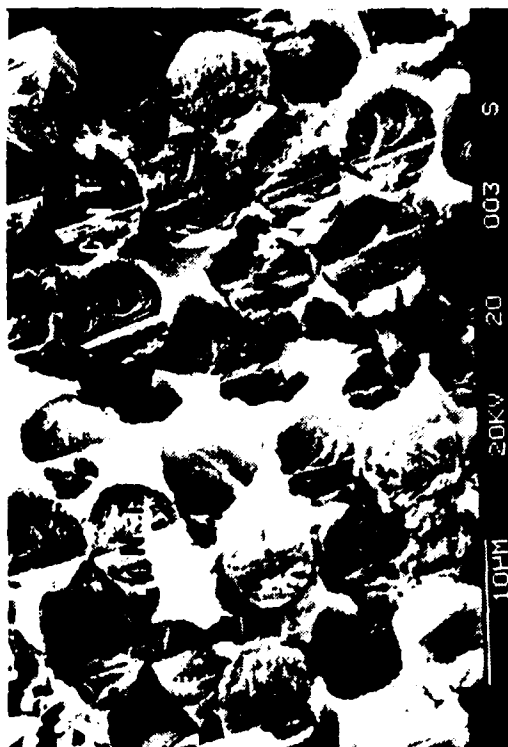
Translaminar Compression, RT/Dry. Optical examination revealed both tensile and compressive regions, as was found on the translaminar tension specimens (Fig. 4.4-101). The compressive zone in this specimen was approximately a third of the fracture surface with the remainder being tensile. The compressive loading appeared to have initiated a tensile crack on the opposite surface which propagated toward the notch and intersected the compressive damage; SEM examination of the tensile portion revealed fiber end fractures that indicated propagation toward the opposite side. (In these specimens, the specified mechanically induced crack direction is from the notch outward). The compressive region revealed a debris-covered surface with fiber end fractures containing both tensile and compressive zones. Resin-rich fractures in the tensile zone revealed rivermarks, indicating propagation opposite to the mechanically induced crack direction, as expected.

As in the translaminar tension specimens, plies oriented at 45 degree were observed protruding from the fracture surface. However, plies oriented at both +45 and -45 were observed on each fracture surface, with the +45 degree plies dominating. Delaminations were observed in these protruding plies.

Macroscopically, the fractures were jagged due to protruding plies. The most outstanding features were the delaminated 45 degree plies which gave the appearance of

Figure 4.4-101. SEM Fractographs of Room Temperature/Dry, Translaminar Compression Fracture in C3K 8-HS/PMR-15

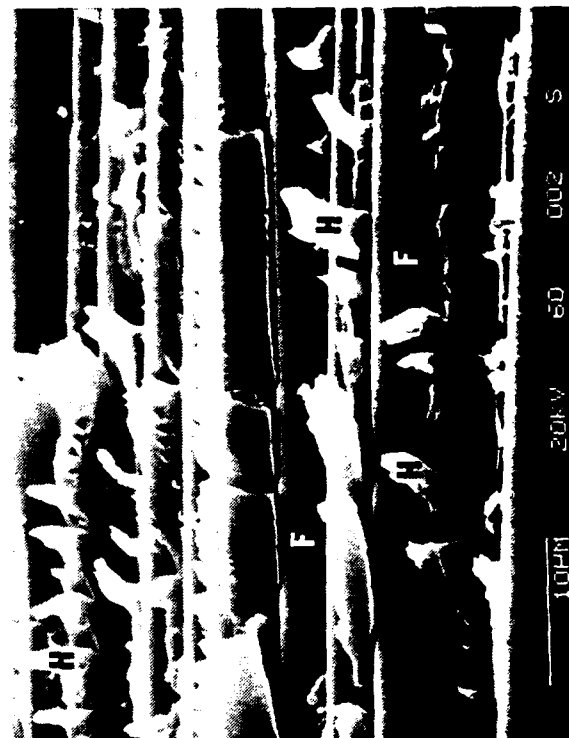
Interlaminar Mode II Shear, RT/Dry. Optical examination revealed typical Mode II shear fracture features. SEM fractography revealed hackles also typical of Mode II propagation (Fig. 4.4-105). Resin-rich regions between plies contained rivermarks indicating crack propagation in a direction consistent with the mechanically induced direction. These rivermarks are apparently the result of cracking through the ply due to offset crack planes. Bare fibers and matrix separation are normal for a shear failure.

Figure 4.4-105. SEM Fractographs of Room Temperature, Interlaminar Mode II Shear Fracture in IM-7/8551

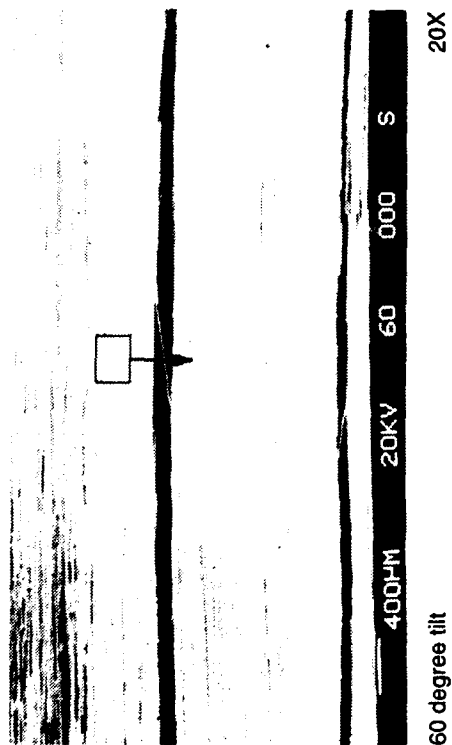
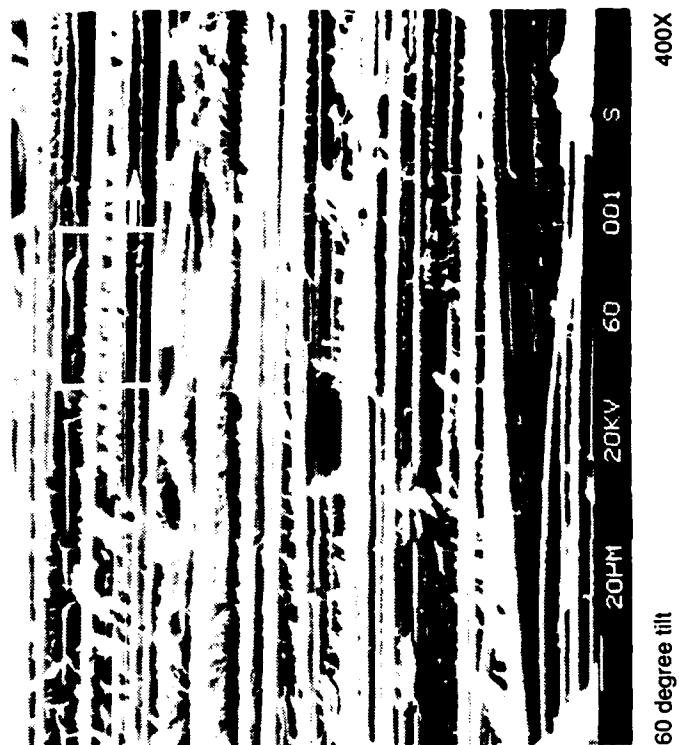
Interlaminar Mode II Shear, 270°F/Wet. Optical examination revealed a typical Mode II shear fracture. SEM examination of the fracture revealed hackles and scallops typical of Mode II fractures (Fig. 4.4-106). The direction of mechanically induced crack propagation could not be determined.

Figure 4.4-106. SEM Fractographs of 270 F/Wet, Interlaminar Mode II Shear Fracture in IM-7/8551

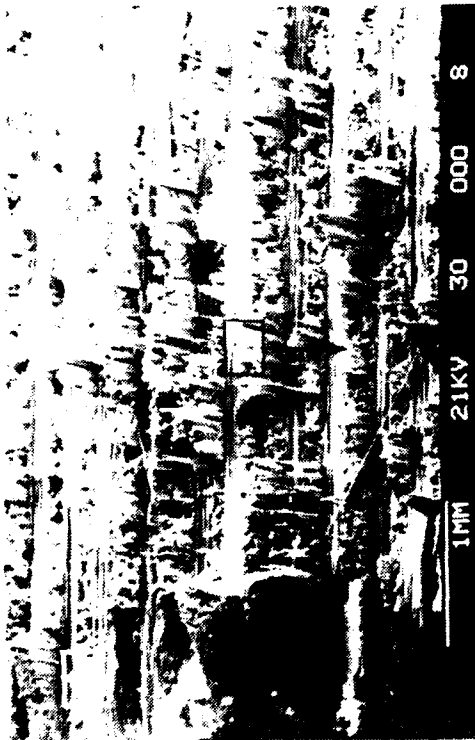
Translaminar Tension, RT/Dry. Optical examination revealed a rough surface due to typical fiber pullout. SEM fractography revealed radial patterns on the fiber ends indicating a resultant crack direction consistent with the mechanically induced direction (Fig. 4.4-107). Fiber/matrix adhesion was good.

Figure 4.4-107. SEM Fractographs of Room Temperature, Translamellar Tension Fracture in IM-7/8551

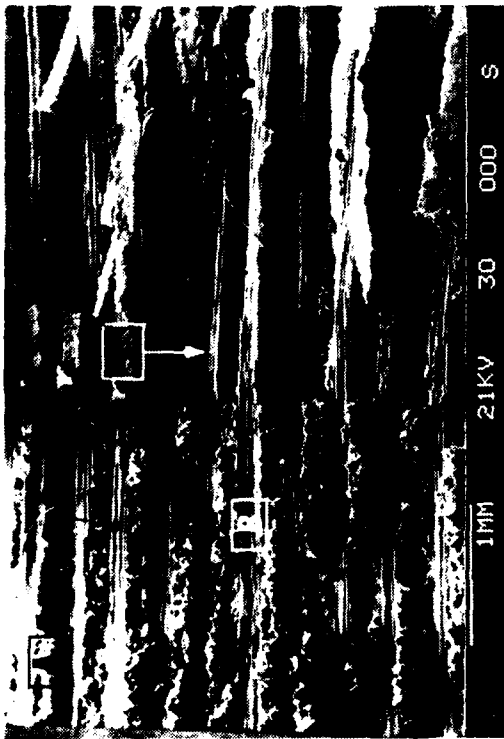
Translaminar Compression, RT/Dry. Optical examination revealed a rough surface comprising approximately 55% compressive failure and 45% tensile failure. Large sections of the 0 degree plies were observed protruding from the compressive portion of the fracture surface. The individual fiber end fractures revealed a compressive zone, a tensile zone, and a neutral axis (Fig. 4.4-108). Fiber end fractures in the generated tensile crack revealed radial patterns which indicated crack direction consistent with the mechanically induced tensile crack direction. Fracture along the 90 degree plies produced some rivermarks with a longitudinal component also indicating crack propagation direction consistent with the mechanically induced direction. Fiber/matrix adhesion was good.

Figure 4.4-108. SEM Fractographs of Room Temperature, Translaminar Compression Fracture in IM-7/8551

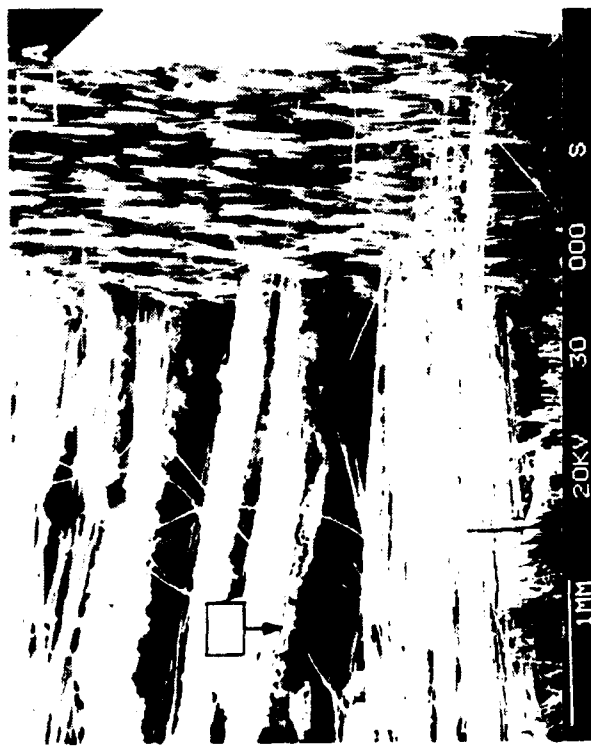
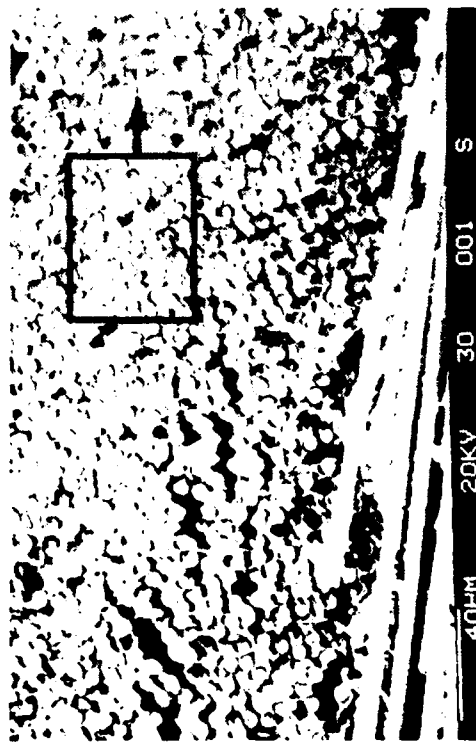
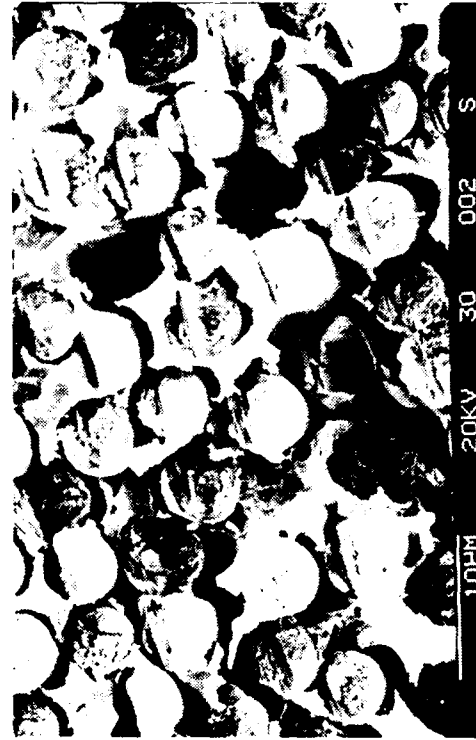
Figure 4.4-109. SEM Fractographs of 270 F/Wet, Translaminar Compression Fracture in IM-7/8551

the compressive region revealed typical fiber end fractures having tensile, compressive, and neutral zones (Fig. 4.4-109). The tensile portion of the fracture revealed substantial fiber pullout and it was not possible to examine enough fiber ends on a single plane to determine crack growth direction. Fiber/matrix adhesion was poor, as evidenced by the fiber pullout.

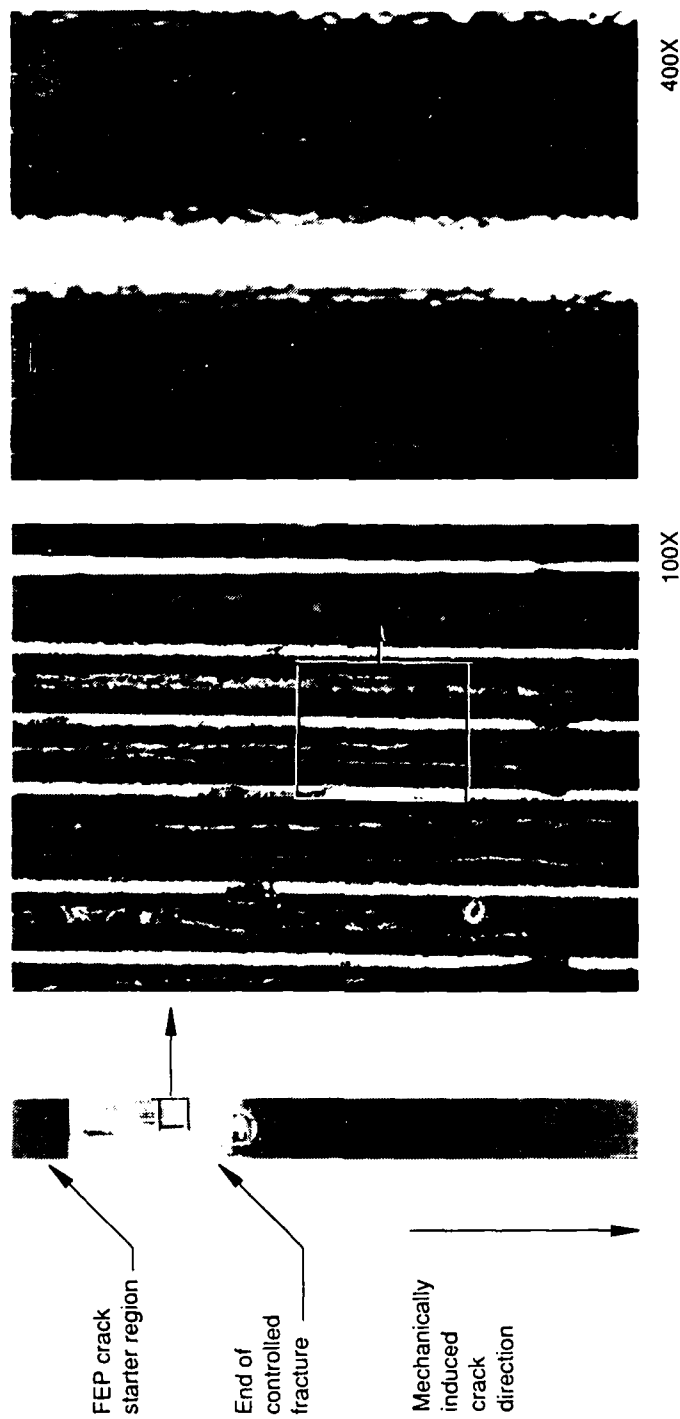
Figure 4.4-110. Optical Photomicrographs of Room Temperature, Interlaminar Mode I Tension, 0/90 Fracture in Boron/Epoxy

The fracture feature most frequently observed under the optical microscope was a resin flow line indicating the overall crack growth direction. This feature was similar to a rivermark (Fig. 4.4-110). The reflection of light from the boron-tungsten filament made it difficult to see some of the fine details of the critical fracture features.

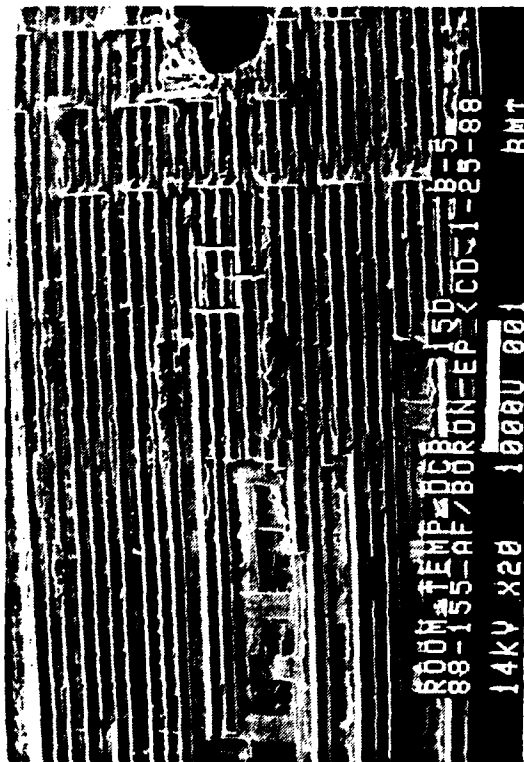
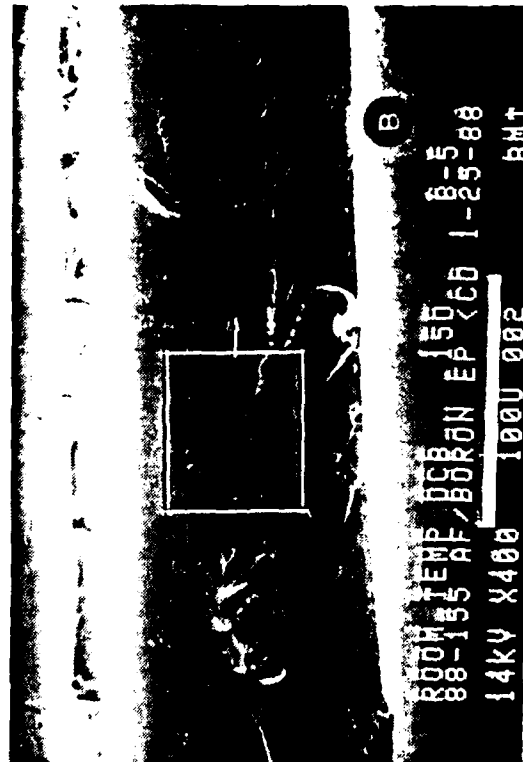
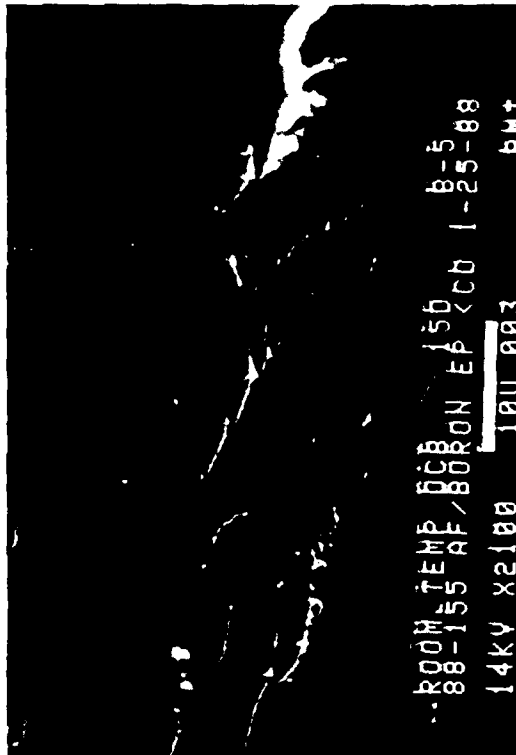
Figure 4.4-111. SEM Fractographs of Room Temperature, Interlaminar Mode I Tension Fracture in Boron Epoxy

SEM analysis showed both rivermarks and resin microflow lines on the fracture surface (Fig. 4.4-111). This indicated that the crack direction could be identified from these microscopic features.

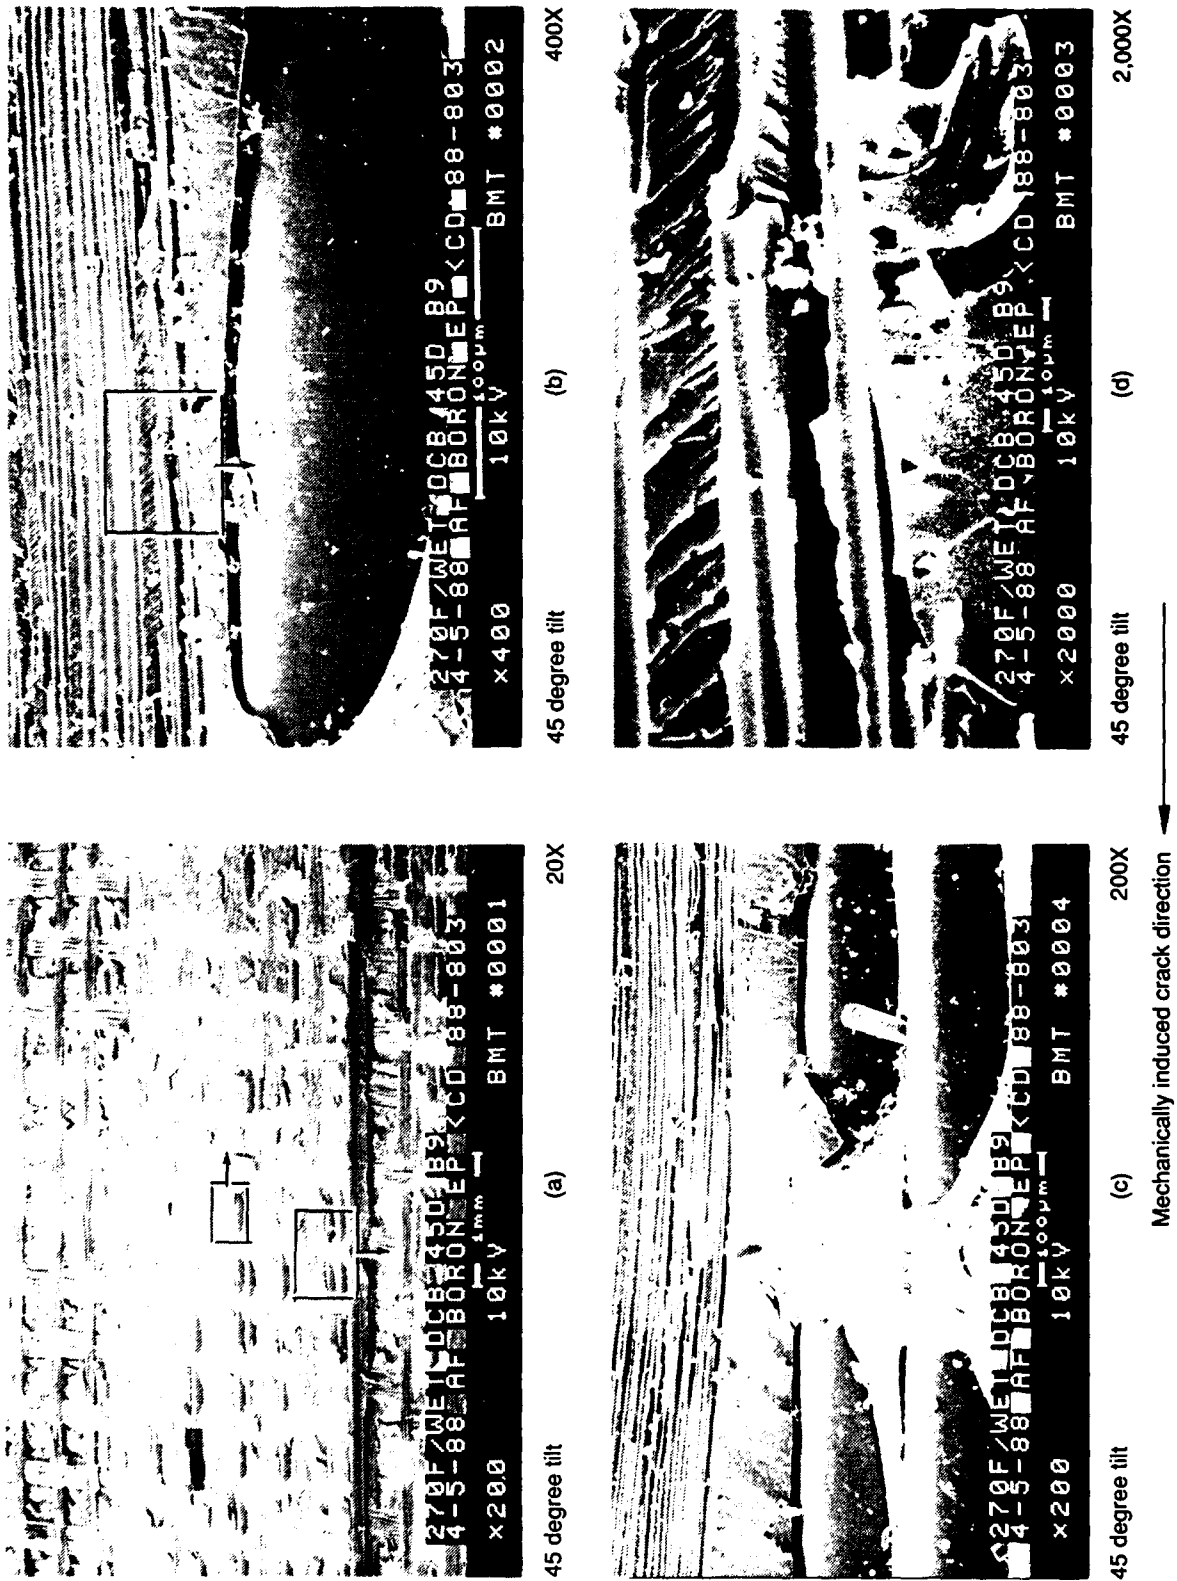
Figure 4.4-113. SEM Fractographs of 270 F/Wet, Interlaminar Mode I Tension Fracture in Boron/Epoxy

Figure 4.4-113 shows the SEM fractographs of the interlaminar Mode I tension specimen exposed to humidity and tested at 270°F. The fracture surface showed

rivermarks in some regions. The major difference between the RT/dry and 270°F/wet specimens was the latter's very poor adhesion at the fiber/matrix interface.

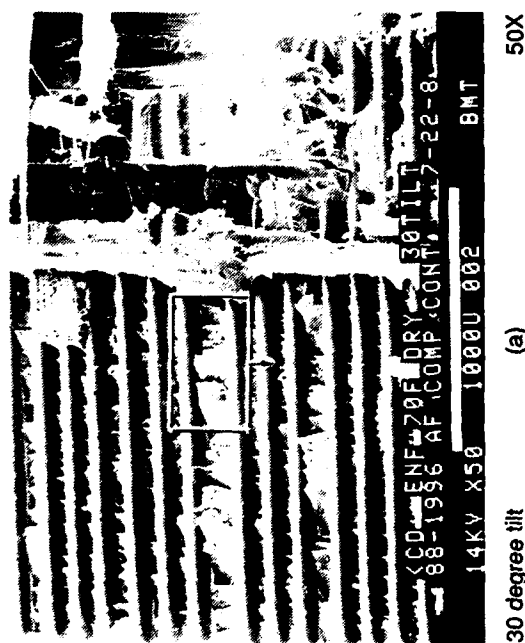
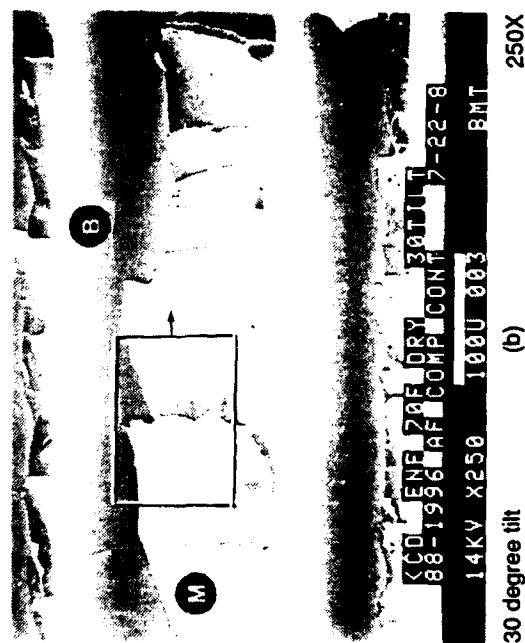
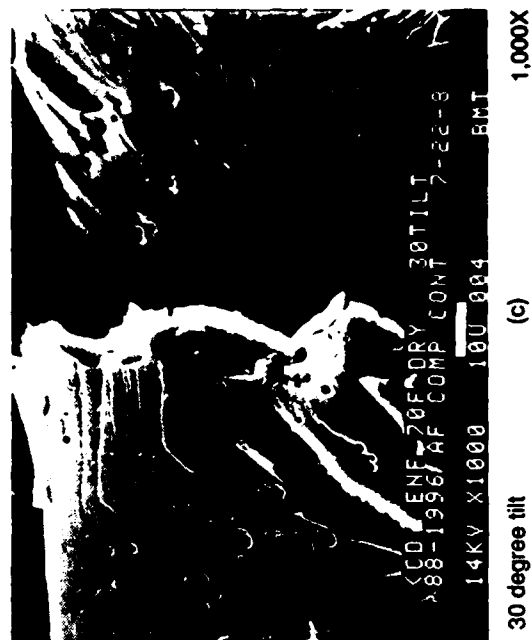
Figure 4.4-114. SEM Fractographs of Room Temperature/Dry, Interlaminar Mode II Shear, 0/90 Fracture in Boron/Epoxy

Interlaminar Mode II Shear, RT/Dry. Under visual examination, the fracture surface was dull and milky due to the formation of hackles. This appearance was similar to that observed in previous work on the carbon-fiber reinforced epoxy system. Due to difficulties in creating a large area of interlaminar Mode II shear fracture surface for this material system, we were unable to provide a macrophotograph of the specimen. However, SEM analysis was performed on the available specimen. The fracture feature revealed resembled the hackles typically observed in the model material system, AS4/3501-6 (Fig. 4.4-114).
